# Manhole Inspection Summary

Manhole # S41WW\_014MH

**Location** Address: **3220 LOCH RAVEN BLVD** Cross Street: **GORSUCH AVE**

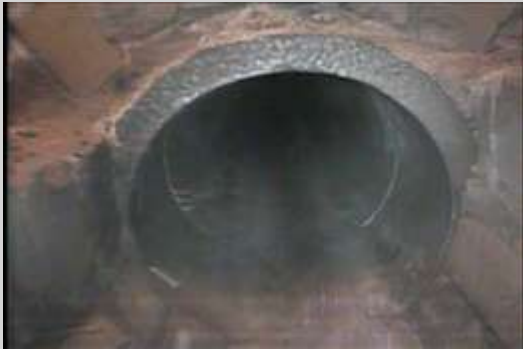
### 10 in. Circular Gravity Sewer Pipe Out @ 12 O'Clock

Pipe Material: **Clay** ☐ Pipe Lined

Invert Depth: **8.10** (ft.) Flow Characteristics: **Fast**

Infiltration: **None** Pipe Seal Cond: **Unknown**

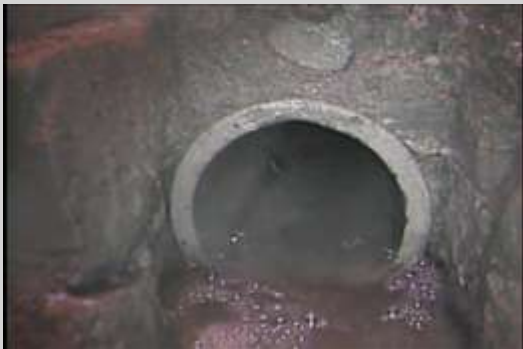
### 6 in. Circular Gravity Sewer Pipe In @ 4 O'Clock

Pipe Material: **Clay** ☐ Pipe Lined

Infiltration: **None** Pipe Seal Cond: **Unknown**
